# Element Materials Technology Denver-Longmont A.K.A. NTS Labs, LLC Test Report for Environmental/Dynamics Testing of the KST7250 and KST3601

KS Technologies, LLC | 11580 Black Forest Road, Suite 60 | Colorado Springs, CO 80908

Element Materials Technology Denver-Longmont | 1601 Dry Creek Drive, Suite 2000 | Longmont, CO 80503 | 303-776-7249 | [www.element.com](http://www.element.com)

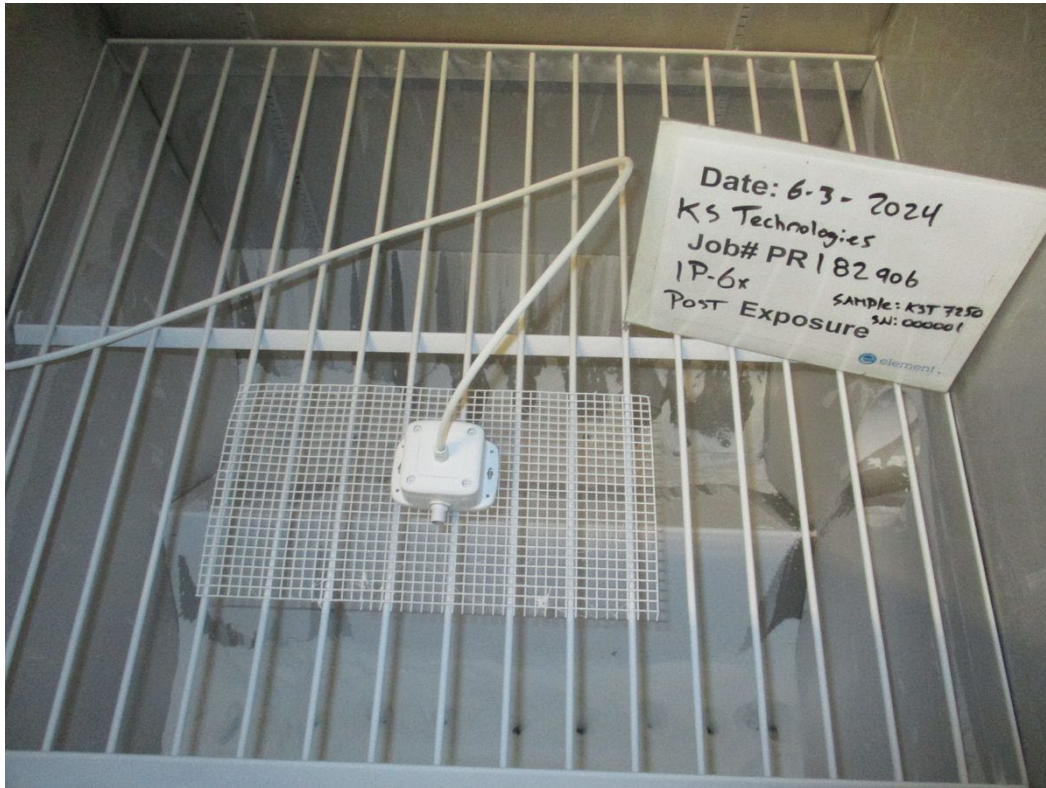
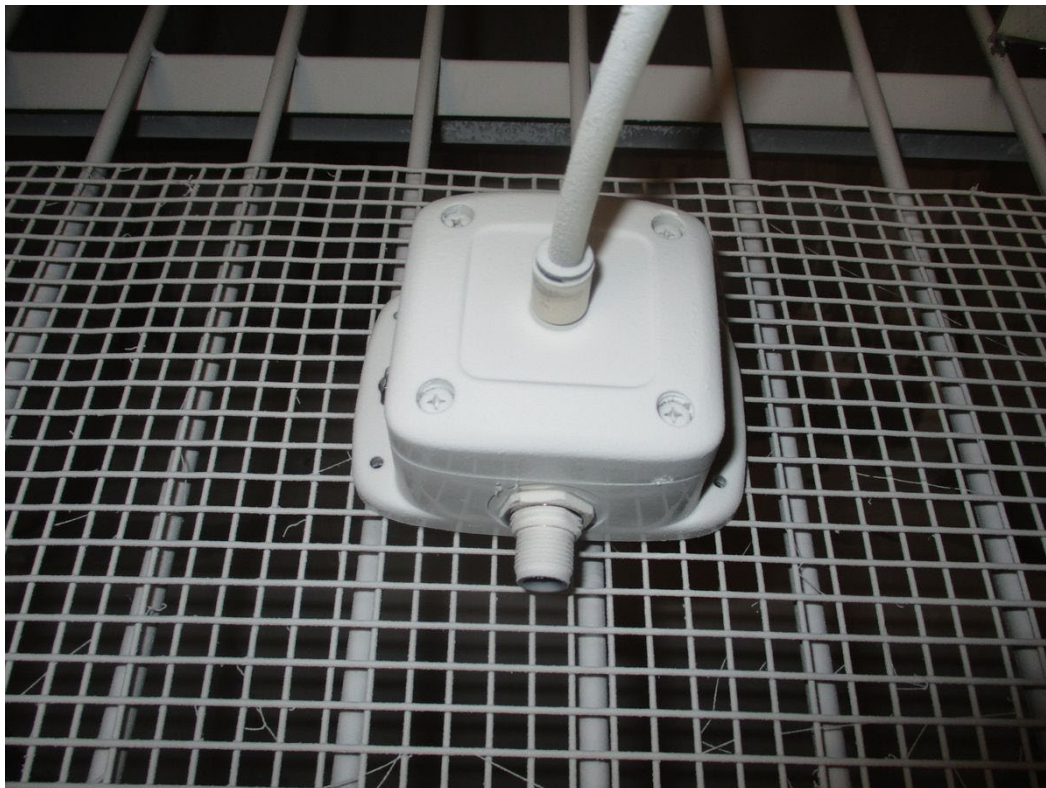
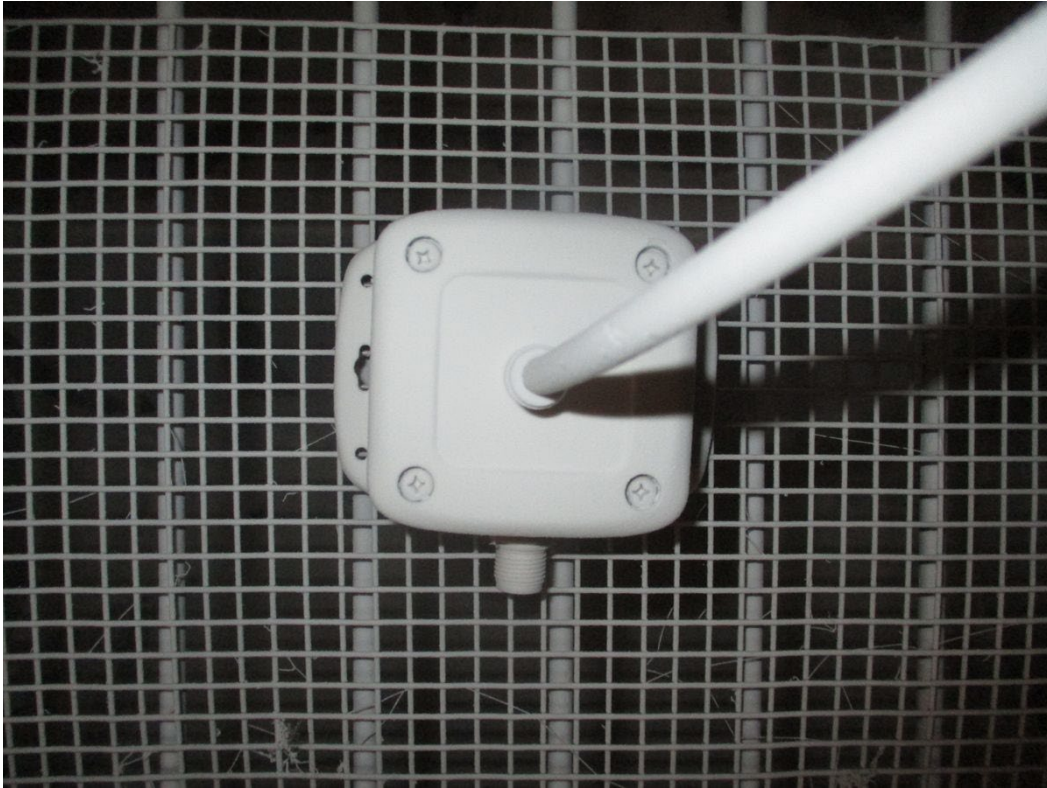
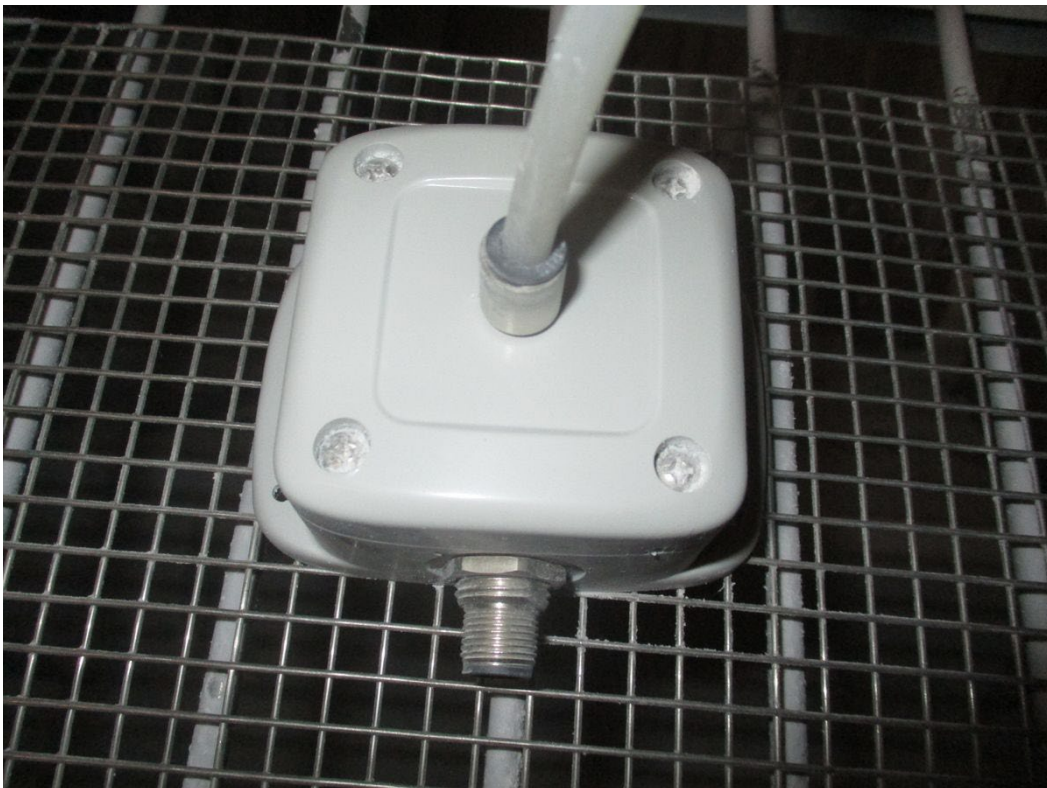
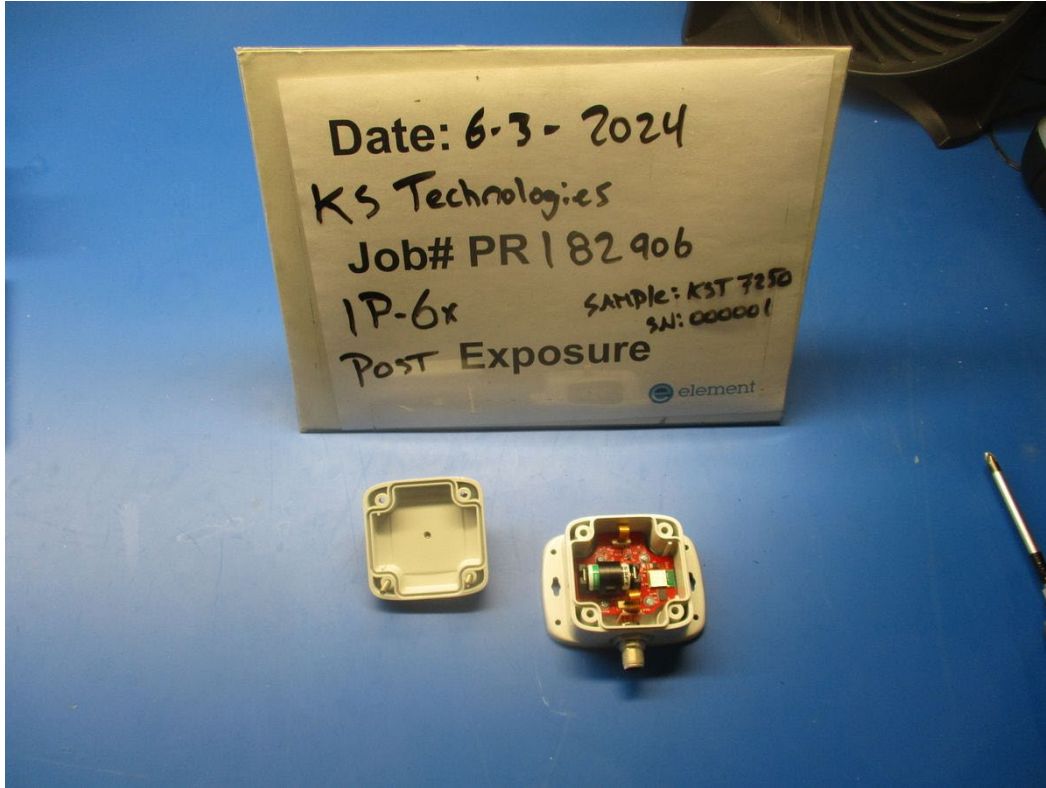
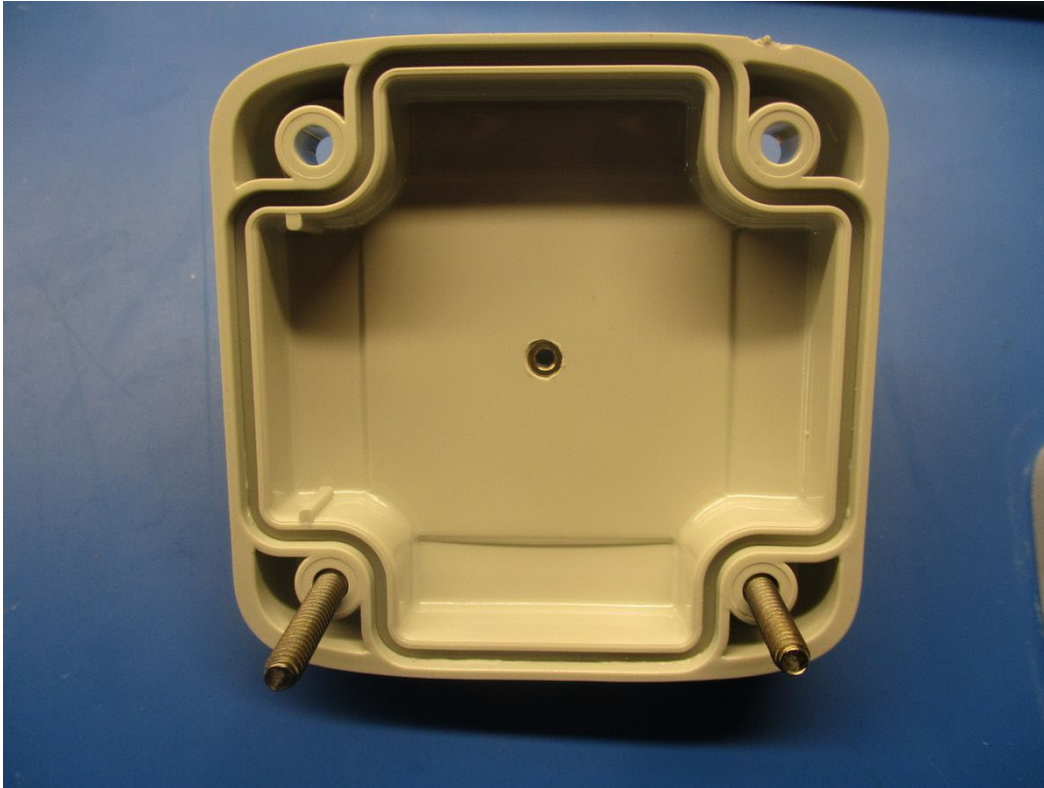
SN-000001\_Post Exposure

5/31/24	1511	Began the 8-hour exposure	CS	
6/3/24	0715	The 8-hour exposure was completed. Opened the chamber, cleared away all the dust from the sample, and removed it from the chamber	CS	
6/3/24	0720	Opened the sample and performed a visual inspection of the sample	CS	
6/3/24	0735	No evidence of dust ingress was observed. Results meet the passing criteria for IP-6x	CS	
			CS	
6/3/24	0810	Sample KST3601 was affixed with a hose fitting to allow for pulling a vacuum on the internal cavity of the sample.	CS	
6/3/24	0813	Sample was set up within the dust chamber.	CS	
6/3/24	0813	Per the IEC specification, the target flow for the test shall be 0.97 to 1.45 liters per minute.	CS	
6/3/24	0815	The chamber was sealed. The targeted flow was achieved so the test duration was set to 2 hours.	CS	
6/3/24	0822	Began the 2-hour exposure	CS	
6/3/24	1025	The 2-hour exposure was completed. Opened the chamber, cleared away all the dust from the sample, and removed it from the chamber	CS

6/3/24	1030	Opened the sample and performed a visual inspection of the sample	CS	
6/3/24	1045	No evidence of dust ingress was observed. Results meet the passing criteria for IP-6x	CS	
6/3/24	1100	Test complete, no visual damage	CS

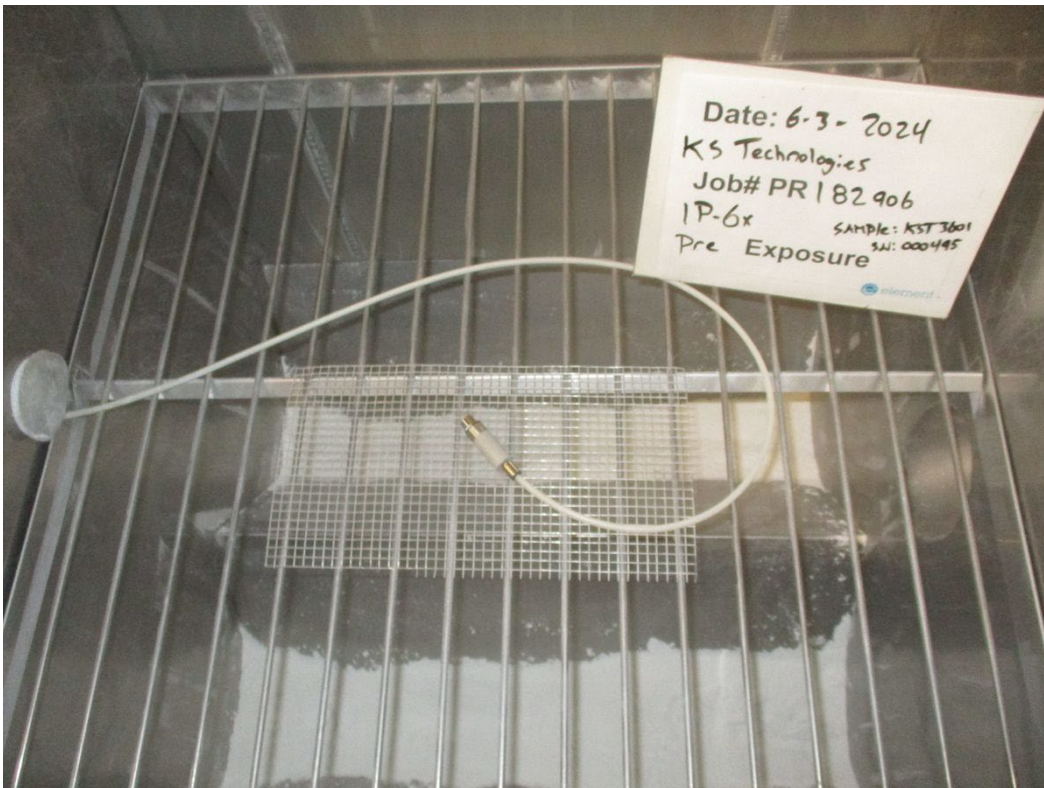
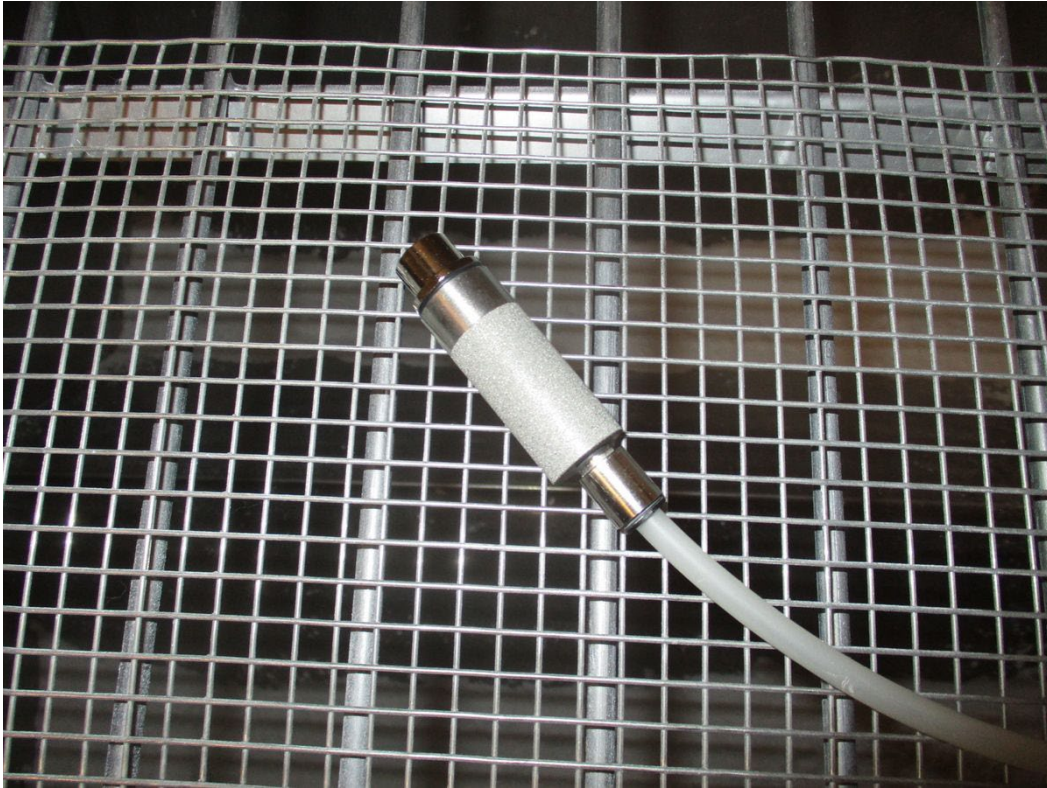
SN-000495\_Pre- Exposure

The EUT showed no visual damage noted after the test was completed.

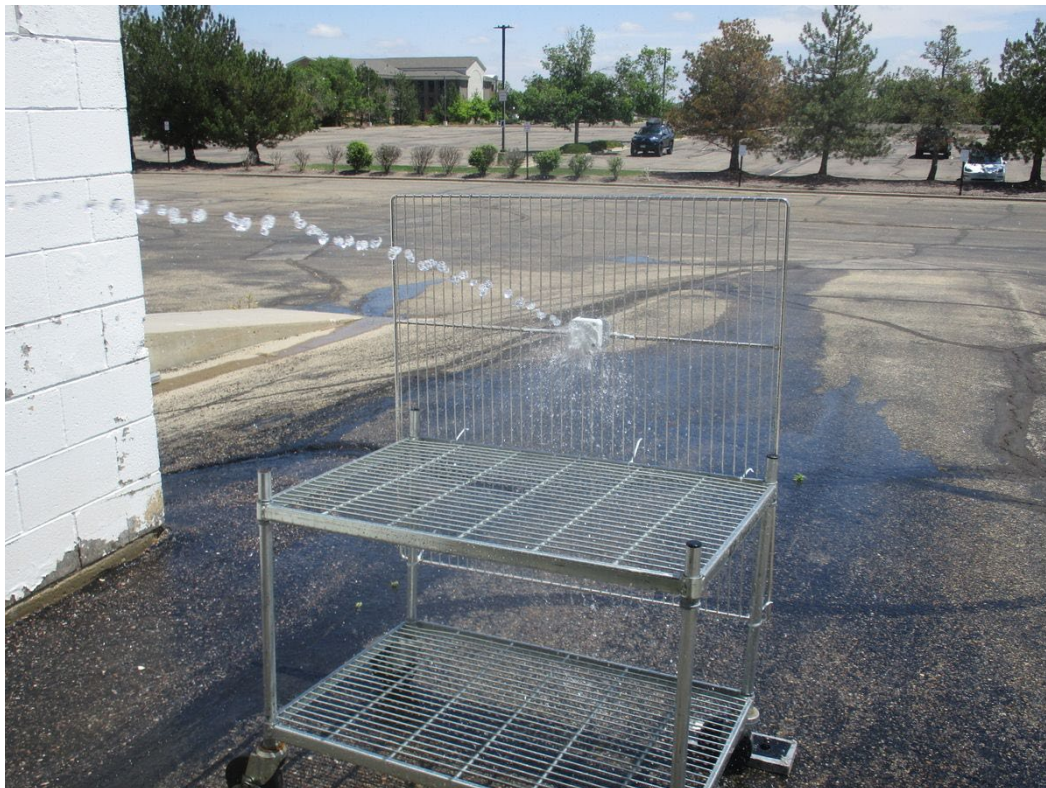
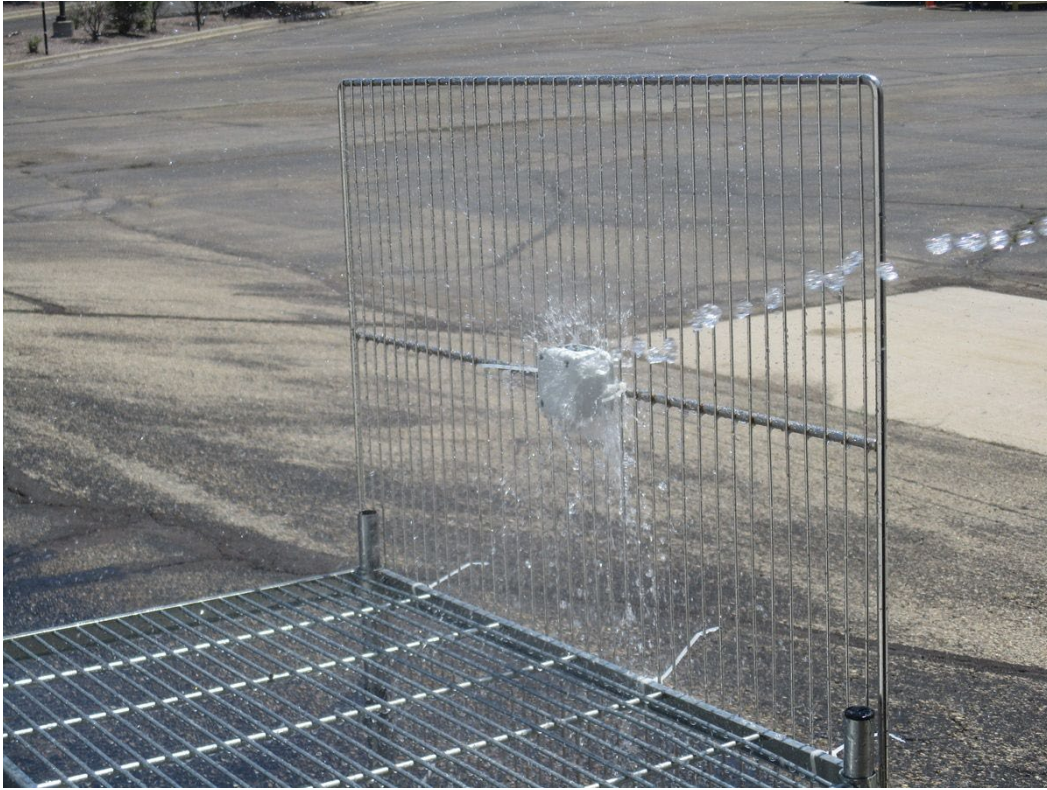
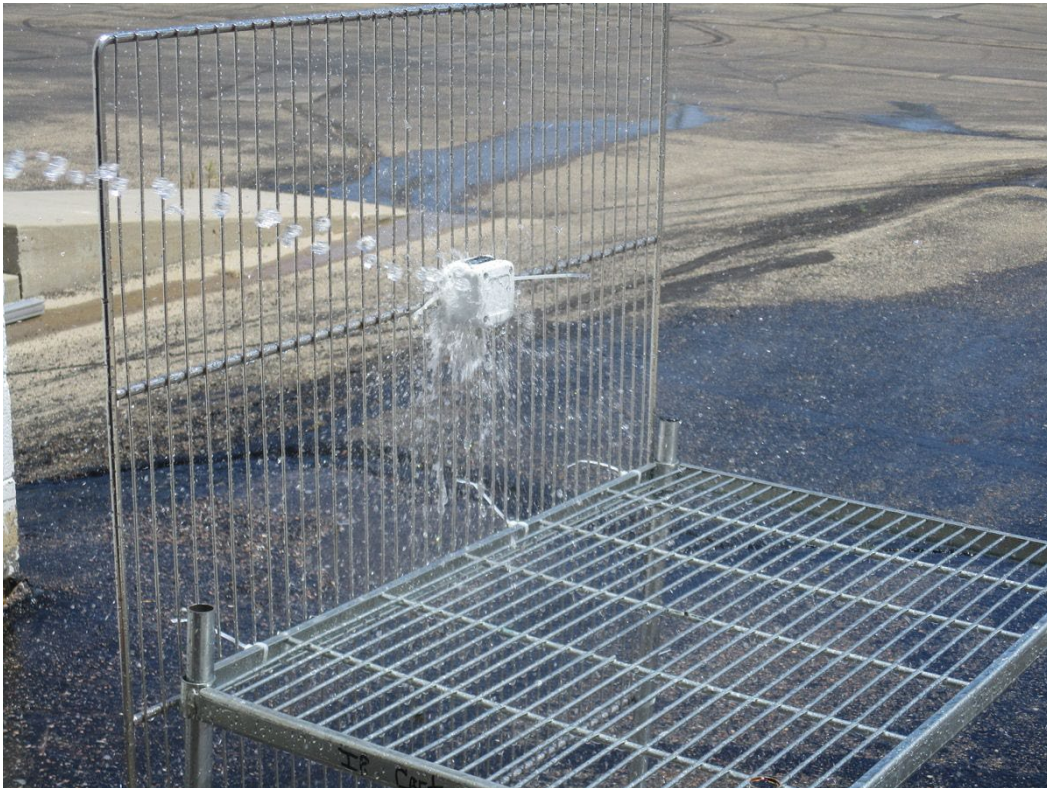
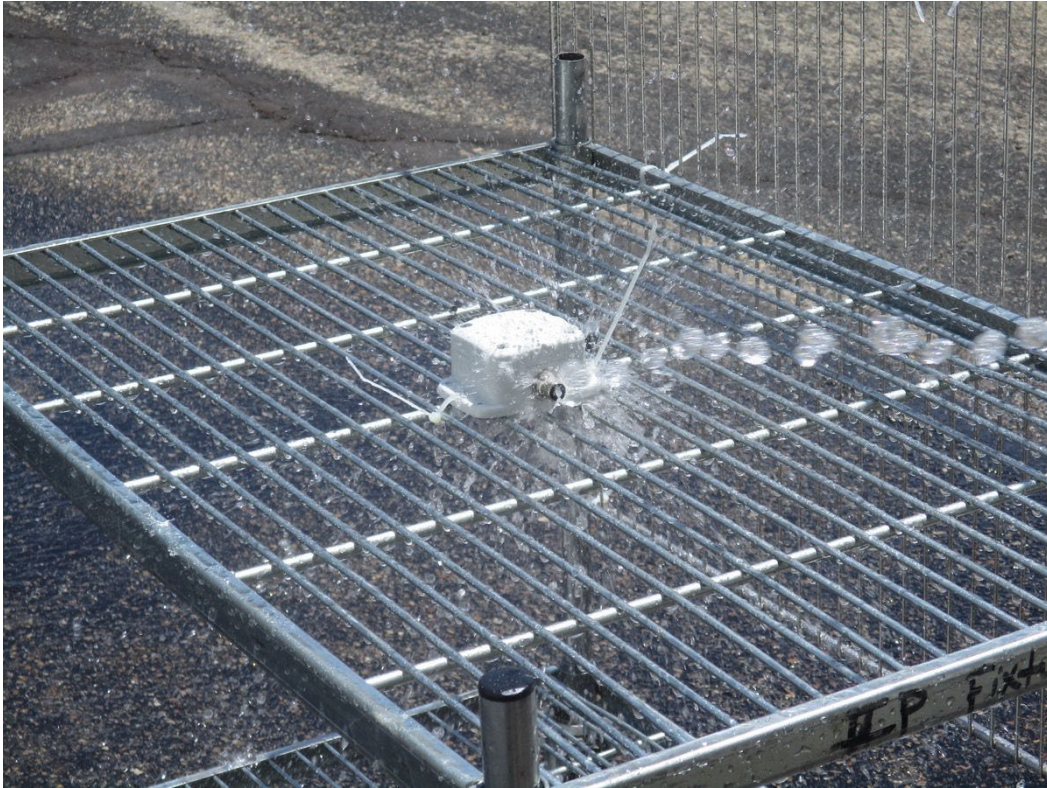
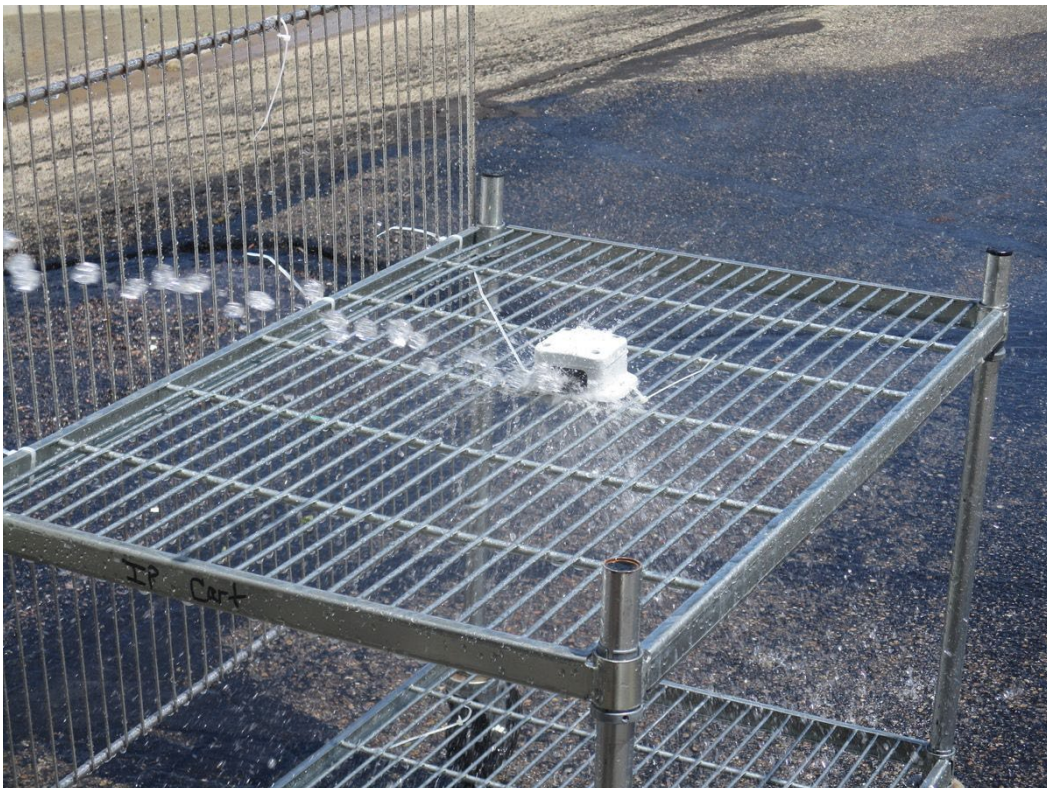
SN-000004\_Exposure

The EUT showed no visual damage noted after the test was completed.

5/31/24	1319	Test was executed on sample KST3601 for a total duration of 3 minutes. Sample was rotated during exposure	CS	
5/31/24	1325	Sample was inspected for signs of water intrusion. No water intrusion was found within the sample	CS	
5/31/24	1340	Test complete, no visual damage	CS

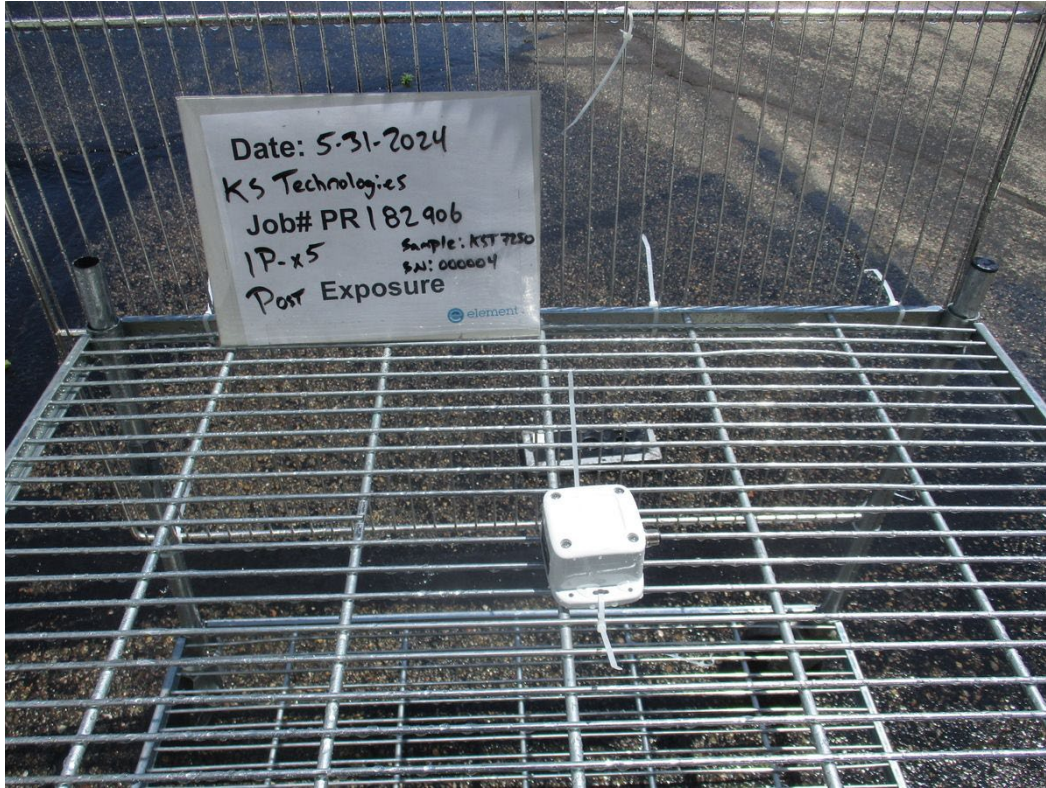
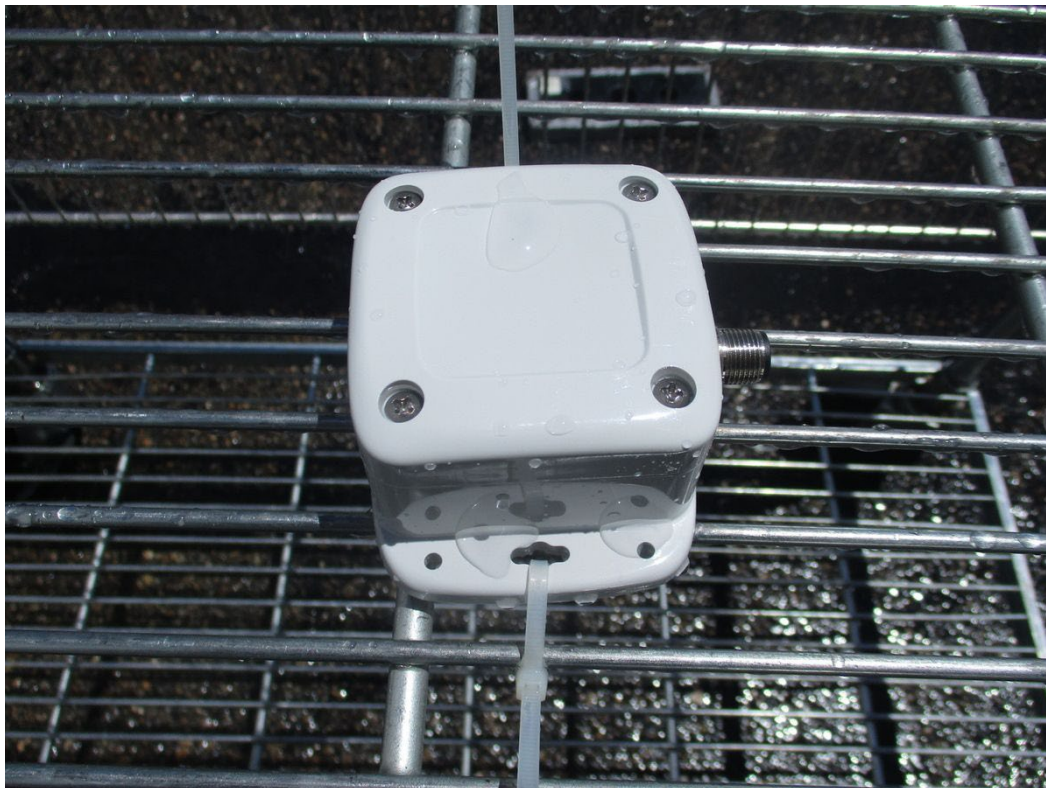
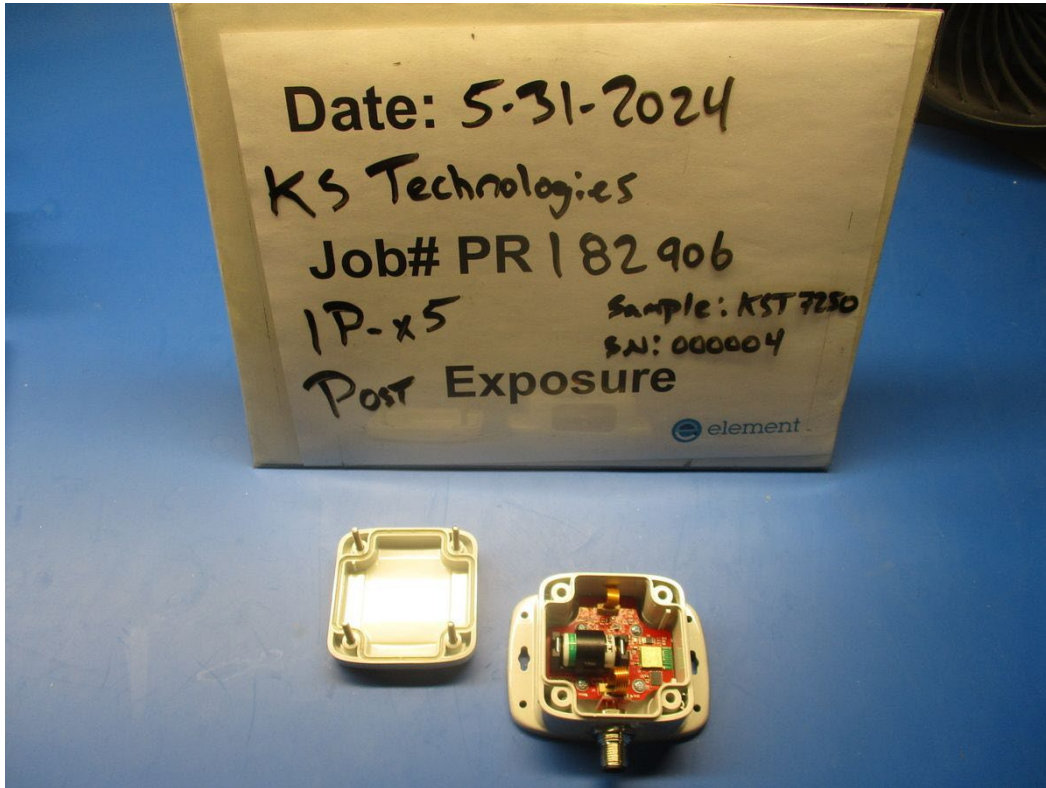
SN-000004\_Post Exposure

Test Log				
MJO No: PR182906		Customer: KS Technologies	Test Specification: IEC 60529	Test Performed: IP-x5
Date	Time	Log Entry	Tech	
5/31/2024	1215	<b>No visible evidence of damage before testing.</b>	CS	
		<b>IP Design: IP-x5</b>	CS	
		<b>Test Means: Water jet hose nozzle - 6.3 mm diameter</b>	CS	
		<b>Water flow rate: 12.5 l/min</b>	CS	
		<b>Duration: 1 min/m at least 3 min</b>	CS	
		<b>Distance from nozzle to enclosure surface: Between 2.5 m and 3 m</b>	CS	
		<b>Water Temperature: The water temperature does not differ from that of the specimen by more than 5 K.</b>	CS	
5/31/24	1220	Sample temperatures were within 5 K of the water temperature	CS	
5/31/24	1225	Setup sample KST7250	CS	
5/31/24	1230	Test was executed on 5 sides of sample KST7250 for a total duration of 3 minutes	CS	
5/31/24	1240	Sample was inspected for signs of water intrusion. No water intrusion was found within the sample	CS	
5/31/24	1315	Setup sample KST3601	CS

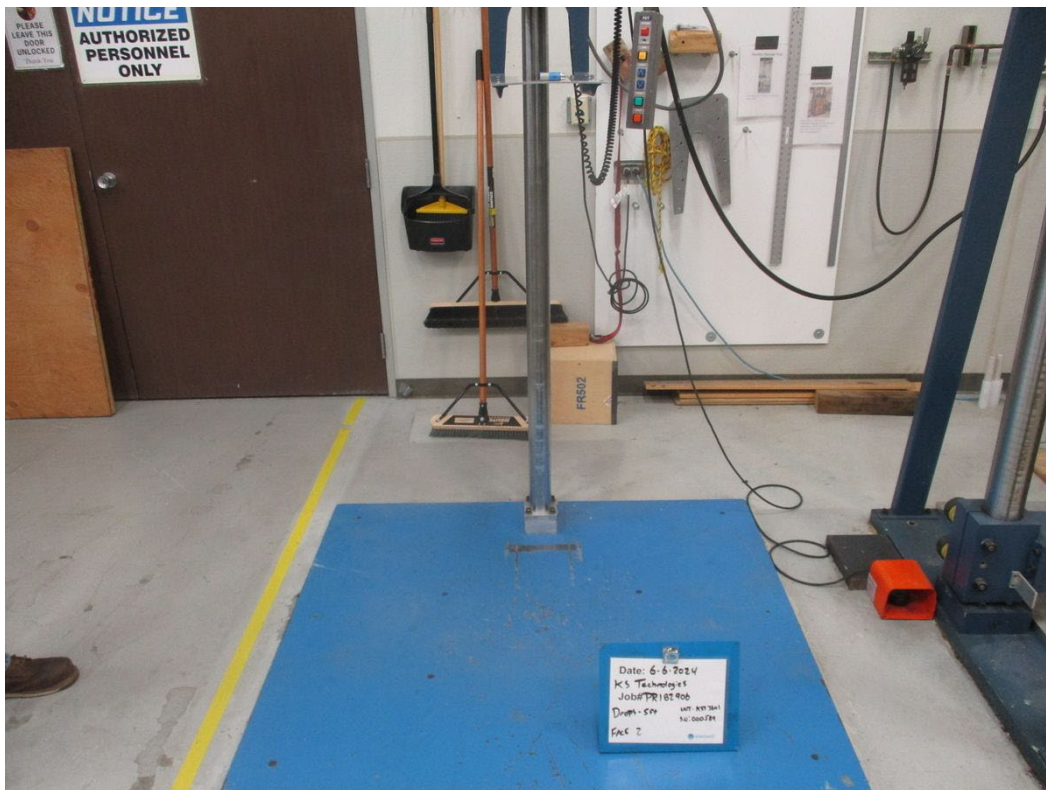
SN-000589\_Drops\_Face 2

The EUT showed visual damage noted after the test was completed. The EUT's results will be determined by KS Technologies, LLC.

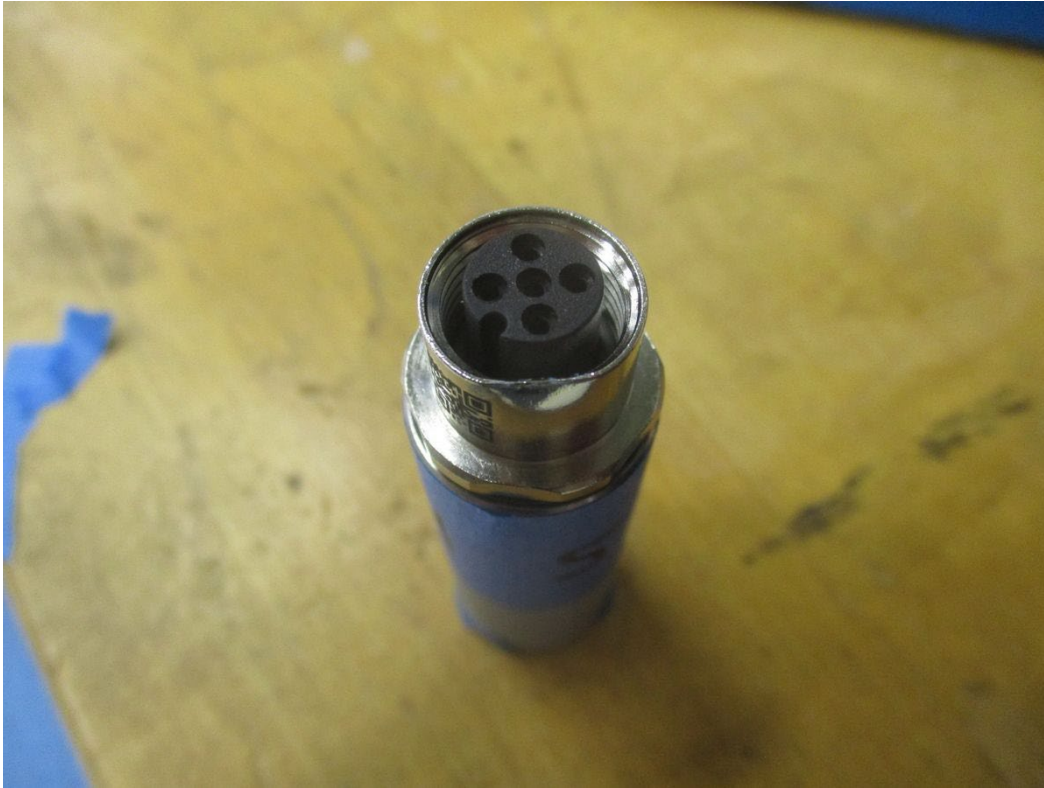
SN-000589\_Drops\_Face 3\_Post Exposure

1627	Edge 4-3	Drop 5	000589	Perform a Drop on Edge 4-3 from a height of 5 feet	CS	
					After the drop on Edge 4-3 the UUT showed signs of denting on the connector end	CS	
6/17/2024					UUT will be dropped from a height of 1000 mm on to a piece of steel backed by concrete. Swing Arm Drop tester will be used for height reference and UUT will be allowed to freefall	CS	
	1428	Face 3	Drop 1	000005	Perform a drop from a height of 1000 mm on Face 3	CS	
	1429	Face 2	Drop 2	000005	Perform a drop from a height of 1000 mm on Face 2	CS	
	1430	Face 1	Drop 3	000005	Perform a drop from a height of 1000 mm on Face 1	CS	
	1431	Face 6	Drop 4	000005	Perform a drop from a height of 1000 mm on Face 6	CS	
	1432	Face 5	Drop 5	000005	Perform a drop from a height of 1000 mm on Face 5	CS	
	1434	Face 4	Drop 6	000005	Perform a drop from a height of 1000 mm on Face 4	CS	
	1435	Face 3	Drop 7	000005	Perform a drop from a height of 1000 mm on Face 3	CS

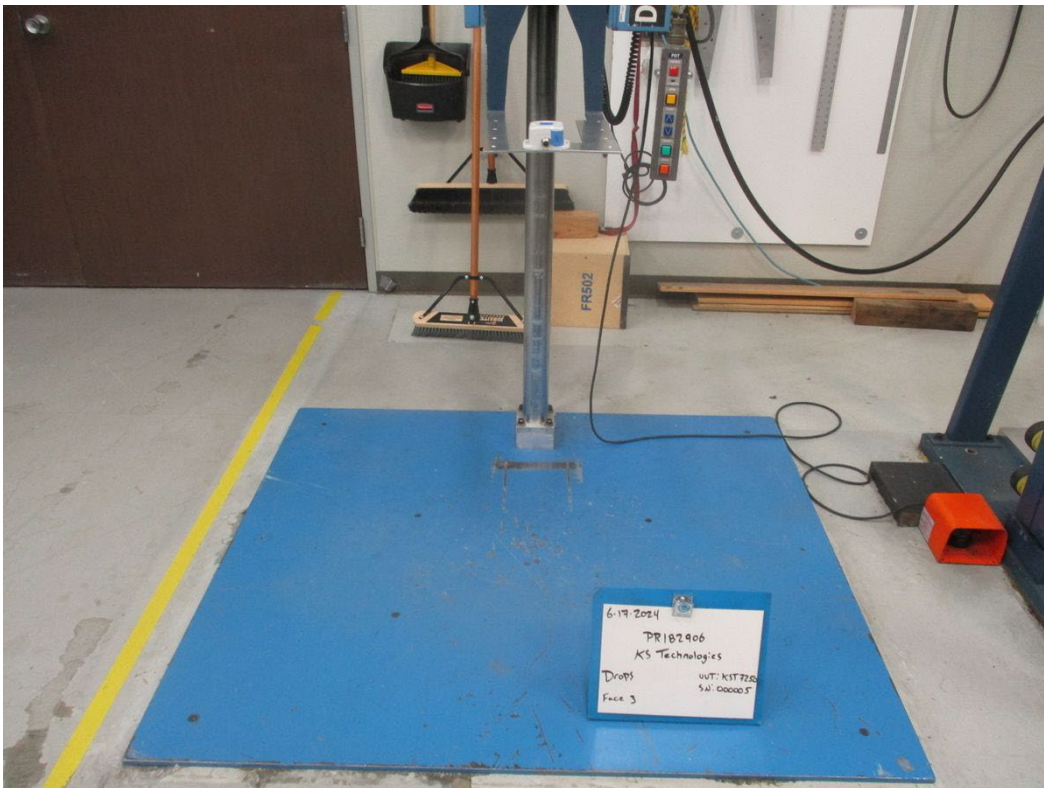
SN-000005\_Drops\_Face 3

1436	Face 2	Drop 8	000005	Perform a drop from a height of 1000 mm on Face 2	CS	
	1436	Face 1	Drop 9	000005	Perform a drop from a height of 1000 mm on Face 1	CS	
	1437	Face 6	Drop 10	000005	Perform a drop from a height of 1000 mm on Face 6	CS	
	1437	Face 5	Drop 11	000005	Perform a drop from a height of 1000 mm on Face 5	CS	
	1438	Face 4	Drop 12	000005	Perform a drop from a height of 1000 mm on Face 4	CS	
				Test complete, connector end showed signs of damage after the drop testing. Customer to make final determination of test results	CS
